Forensic Building Science, Inc.

Insured: Memorial Inn & Suites
Property: 9535 Katy Fwy
Houston, TX 77024
Home: 123 Main St.
Saint Paul, MN 55105-3529

Type of Loss: Hurricane

FIELD REPORT FOR INITIAL STORM DAMAGE INVESTIGATION

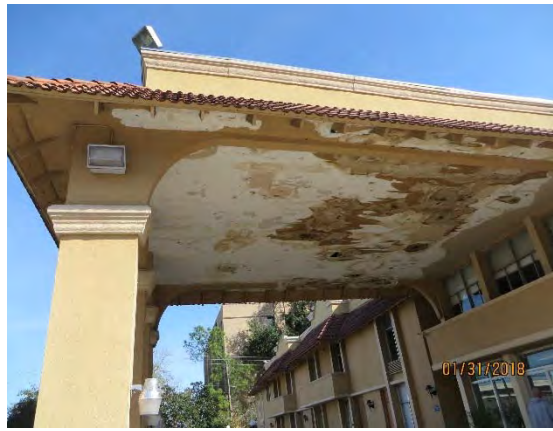
Figure 1A

- The ceiling of the porte-cochere was water damaged and the finish was removed for safety reasons.
- Many of the window air-conditioning units had damage to the plastic fins. Some were said to be broken as a result of the storm, while others were broken from unrelated causes.

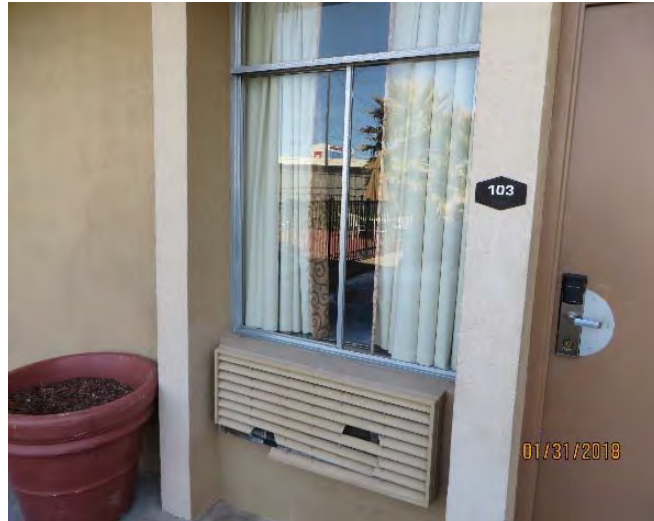
Figure 2

- Several windows were broken from wind or wind-borne debris. Units with broken windows include 104, 114, 116, 117, 124, 166, 171, 177, 184, 209, 257, 261, and 262.
- Some windows have been replaced and others have been removed, but not yet replaced.
- Gaps identified around window frames were new in appearance and were consistent with wind damage. These gaps should be considered storm created openings.

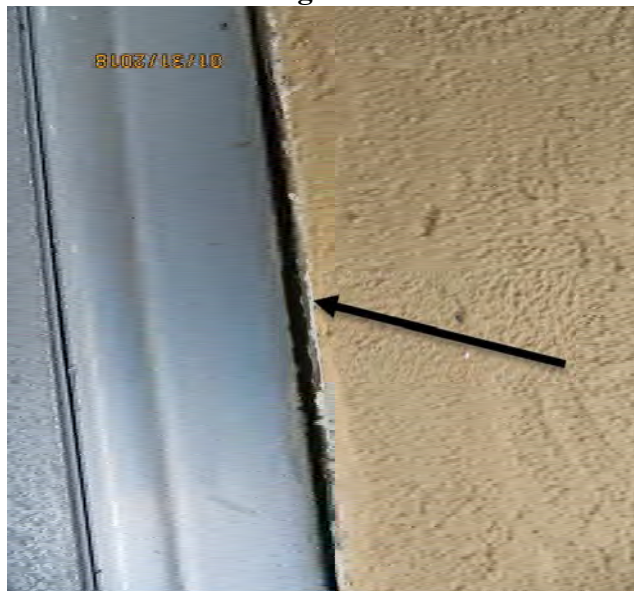
Figure 3A

- Widespread damage identified to the exterior wall finish along the bottom of walls due to standing water during the tropical storm. This was observed by FBS and confirmed by property management. Water caused the parging to separate from the CMU at a number of locations. This damage typically extended up 12" from the grade line.

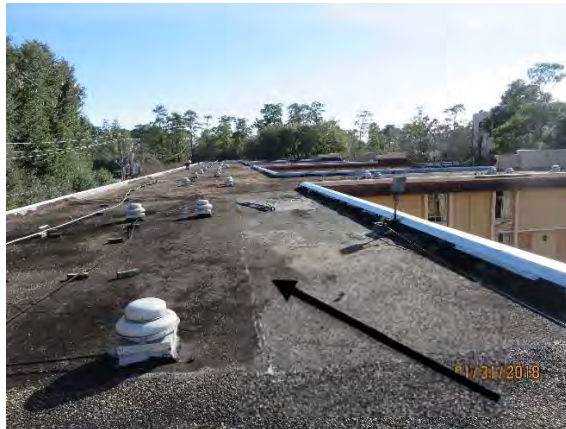
Figure 5

- Parapets are capped with metal. The interior side of the 12-inch high parapets were covered with BUR that extended up the wall and under the metal cap. The exterior side was sloped and clad with concrete tiles, except for the east elevation, which was clad with 3-tab asphalt shingles. Along the southern end of the east elevation, concrete tiles were installed with battens fastened directly through the existing 3-tab shingles.

- Scour and cap sheet separation and debonding was observed on the BUR.[See Figure 5]
- Decorative 6- foot high wood-framed parapets were installed on top of the roof above the functional parapets along the north elevation and the west ends of each wing. The interior side of these parapets were clad with plywood. The top of these parapets were clad with exterior insulation and finish system (EIFS) which was capped with metal. During our inspection, a crew was replacing plywood that had been dislodged during the storm event. In general the plywood was in poor condition.

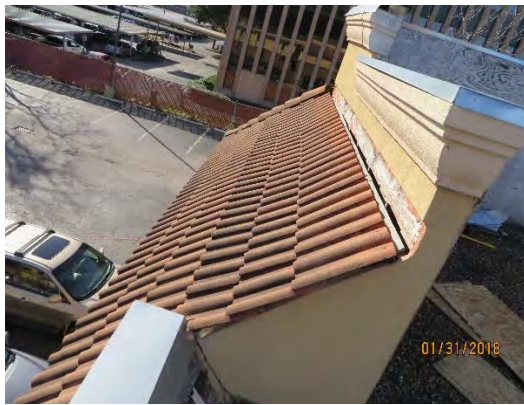
Figure 6

- 2" x 4" non-conventional wood bracing used for tall parapets.

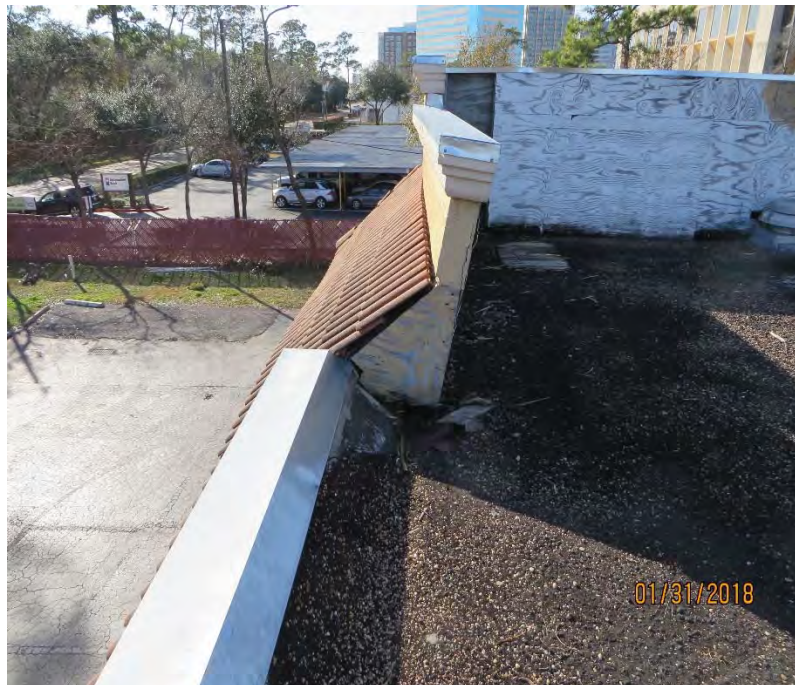
Figure 8 Parpet pushed inward

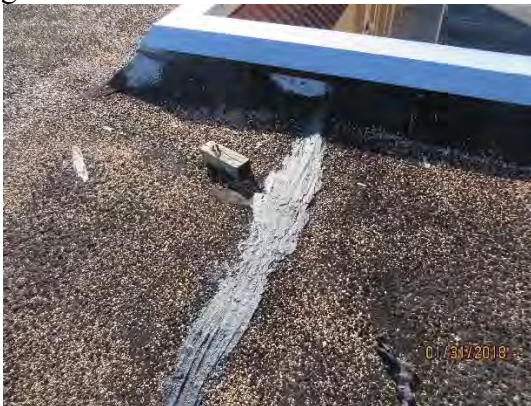
Figure 9

- Roof areas where an additional flood coat was applied
- A temporary repair with a black tarp observed between the first and second wings.

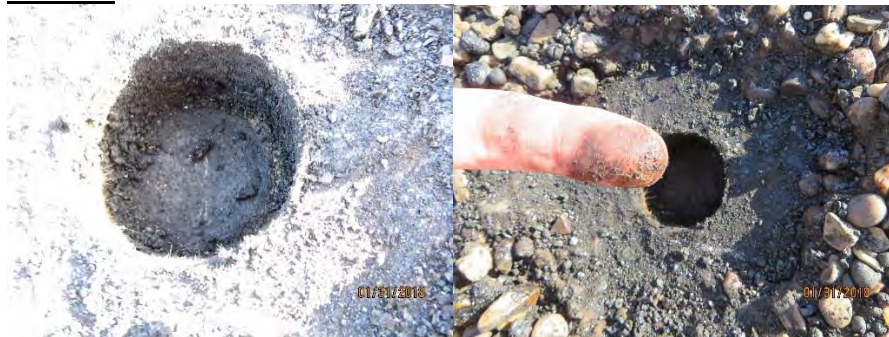
Core #1

- Located on the 1st (northernmost) wing, 13' from South wall, 50' from East wall
- Gravel Ballast

- ½" 3-ply BUR
- ½" fiberglass insulation
- Concrete deck
- All materials were wet

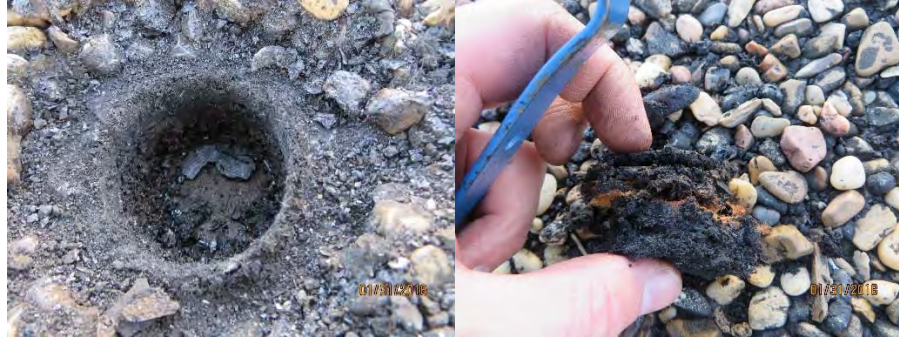
Core #2

- Located on the 3rd (middle) wing, 8' from North wall, 32' from West wall
- Gravel Ballast
- ½" 3-ply BUR
- ½" fiberglass insulation
- Concrete deck
- All materials were wet

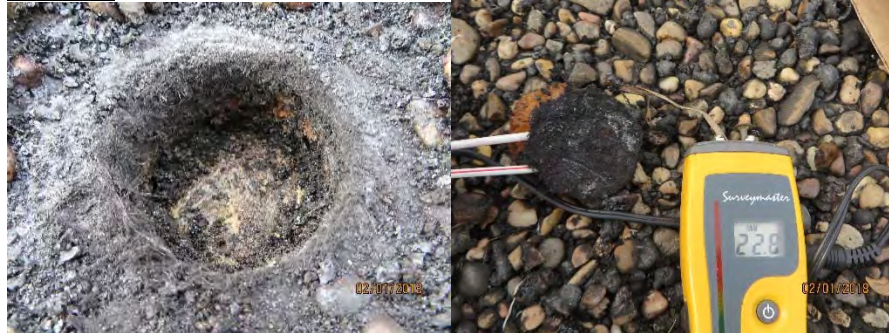
Core #3

- Located on the 5th (southernmost) wing, 7' from South wall, 8' from West wall
- Gravel Ballast
- ½" 3-ply BUR
- ½" fiberglass insulation
- Concrete deck
- All materials were wet

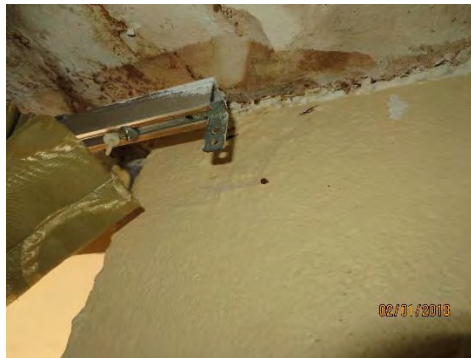
Figure 12

- Water damage to ceiling
- Water damage to wall

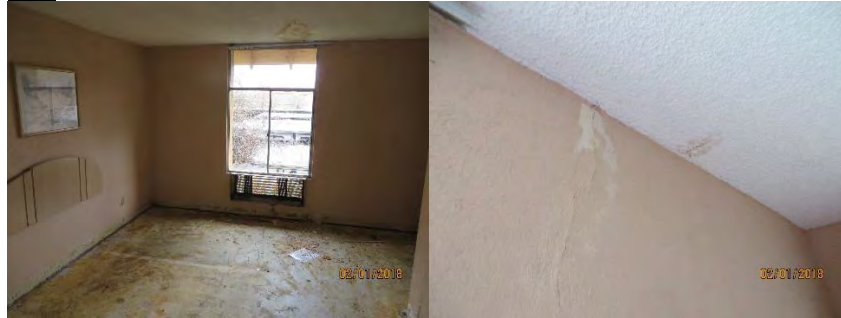
Figures 14 and 14A

- Water damage to ceiling
- Water damage to wall
- Water damage to carpet
- A/C unit missing

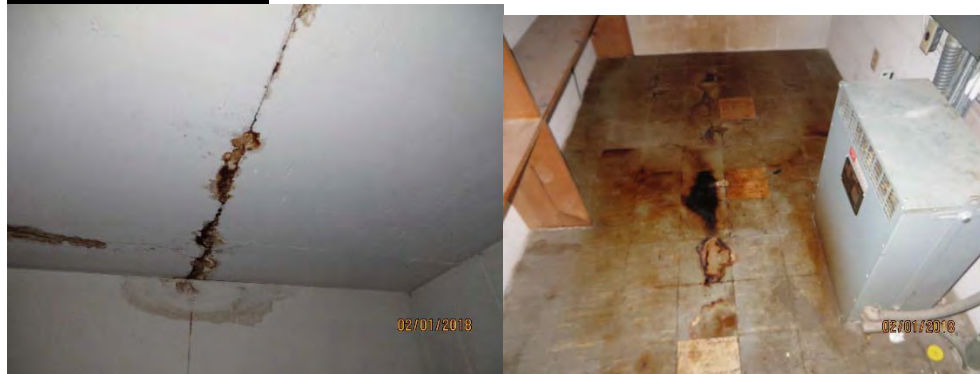
Figures 15 and 15A

- Water damage to ceiling
- Water damage to wall
- Water damage to floor

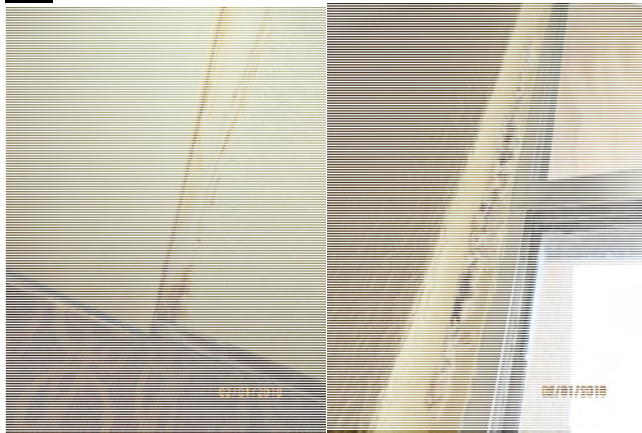
Figures 16 and 16A

- Water damage to wall

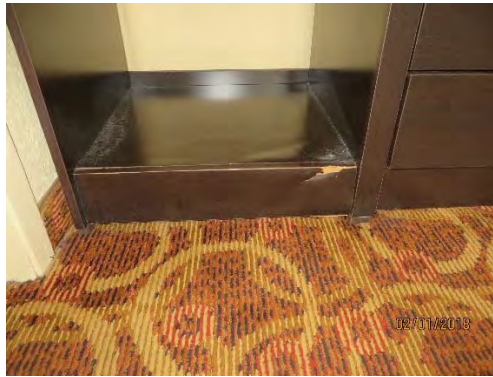
Figure 17

- Water damage to carpet
- Water damage observed on wood dresser

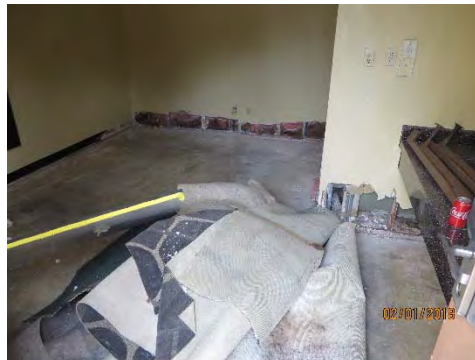
Figure 18

- Water damage to carpet
- Water damage to base of wall

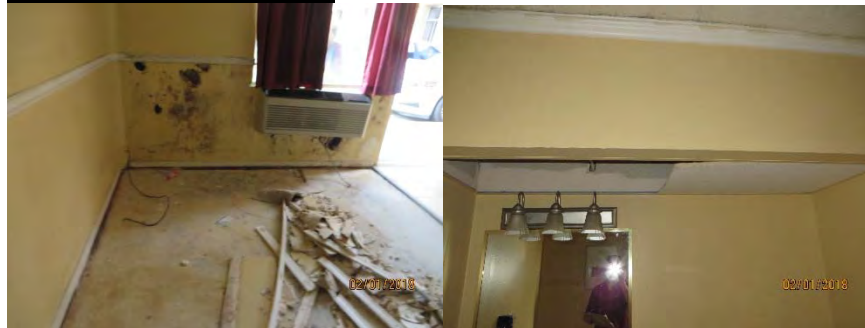
Figures 19 and 19A

- Water damage to carpet
- Water damage to wall
- Water damage to ceiling

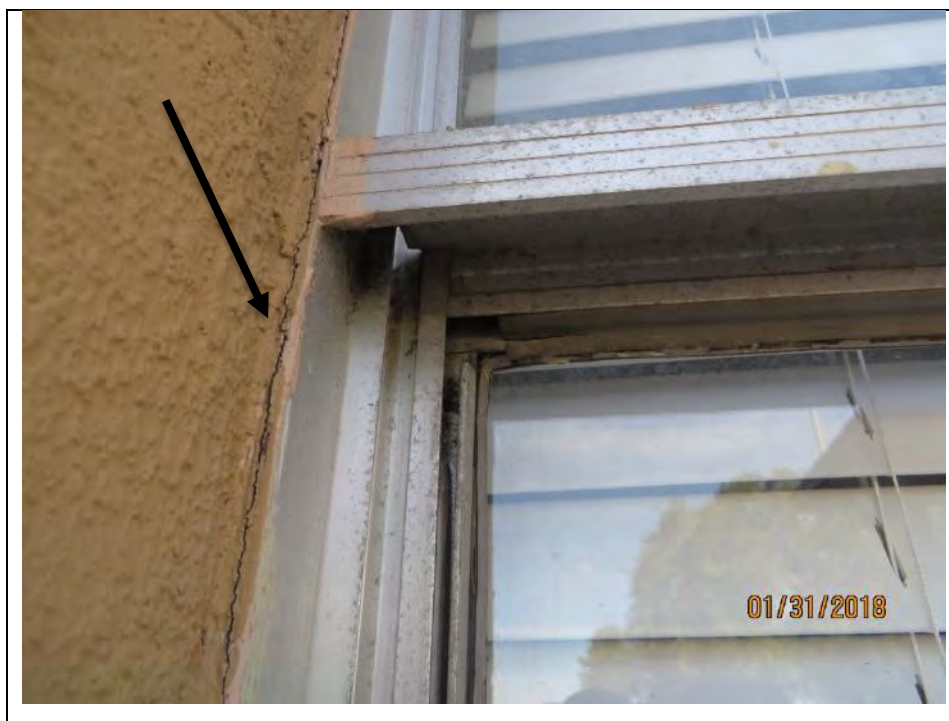
Figure 10. Separation between window frame and stucco (KJS)

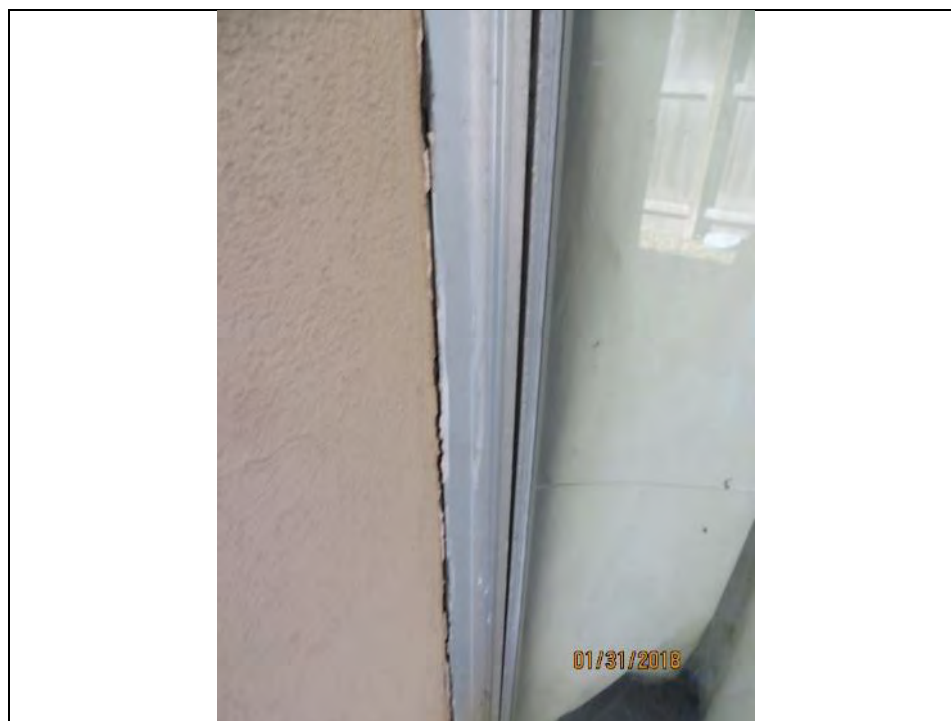
Figure 33. Window shifted in opening (KJS)

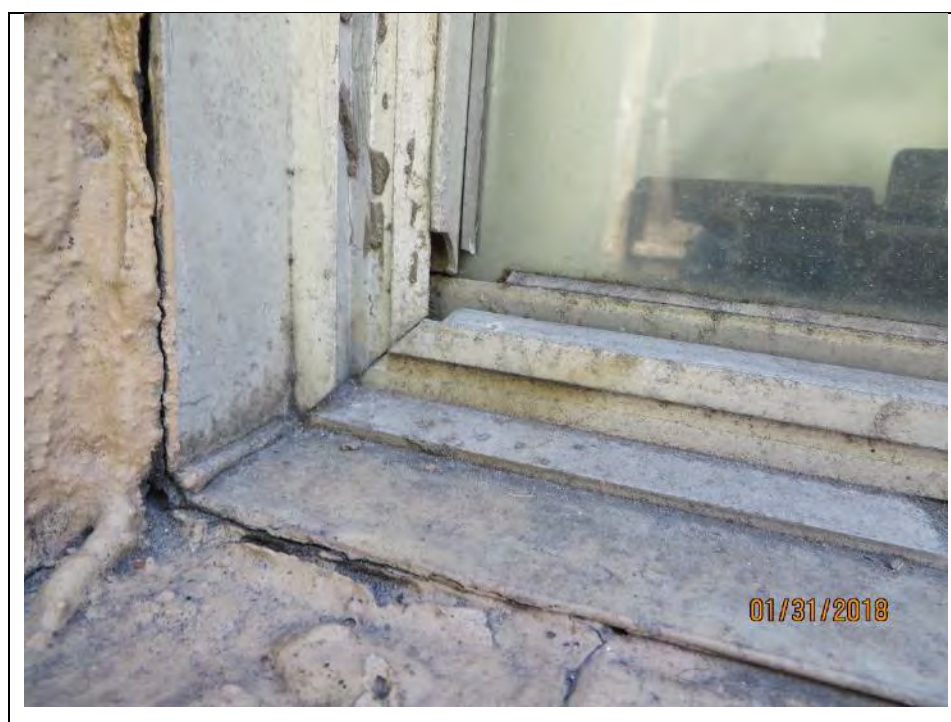
Figure 34. Window shifted in opening (KJS)

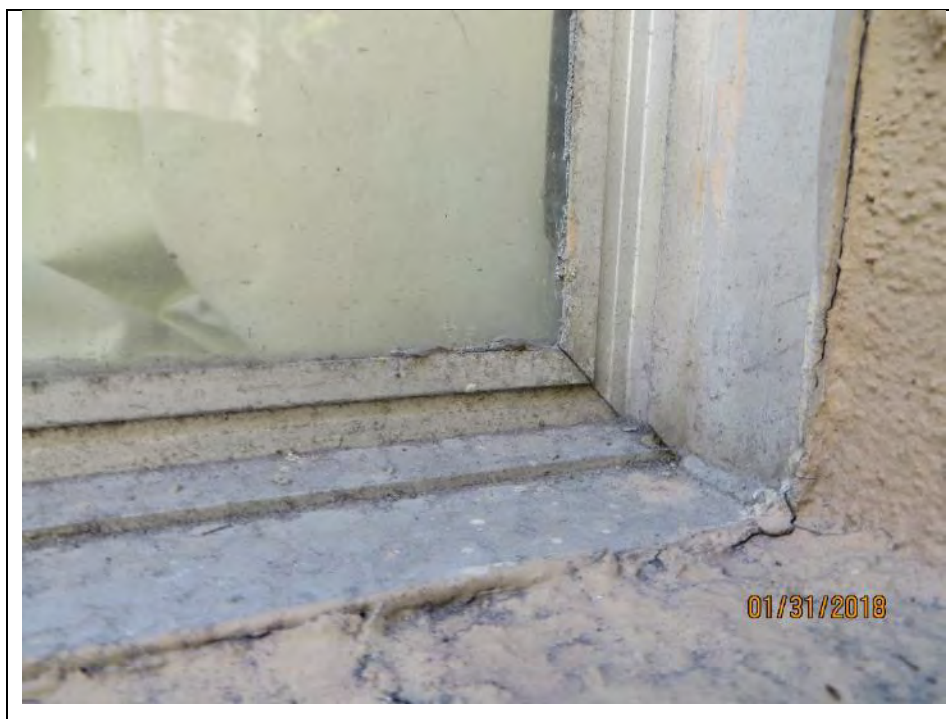
Figure 36. Corner miter opened KJS)

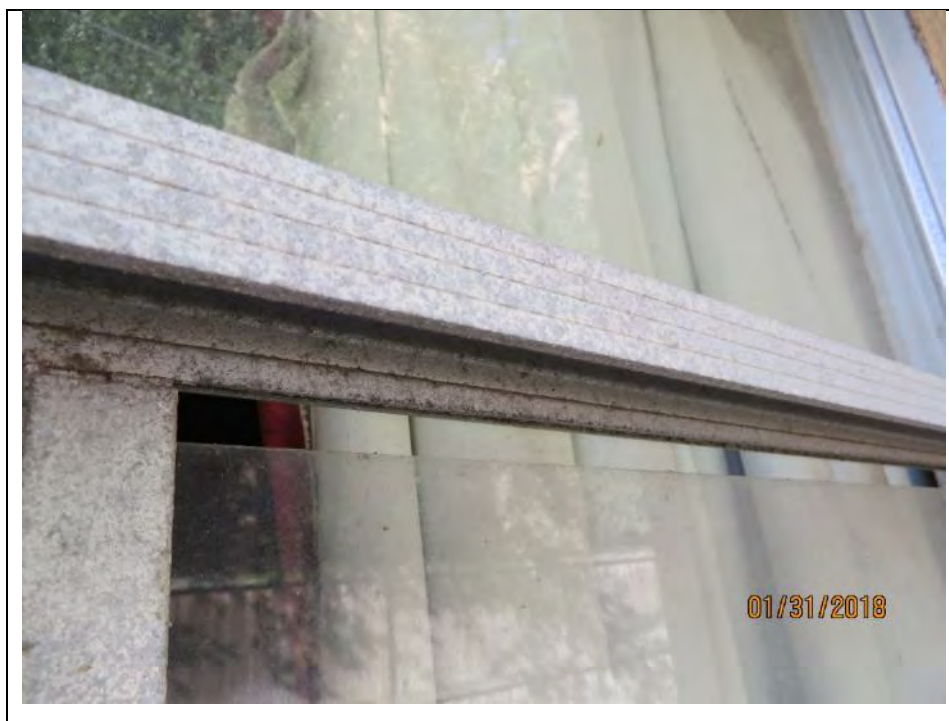
Figure 55. Glass slipped down (KJS)

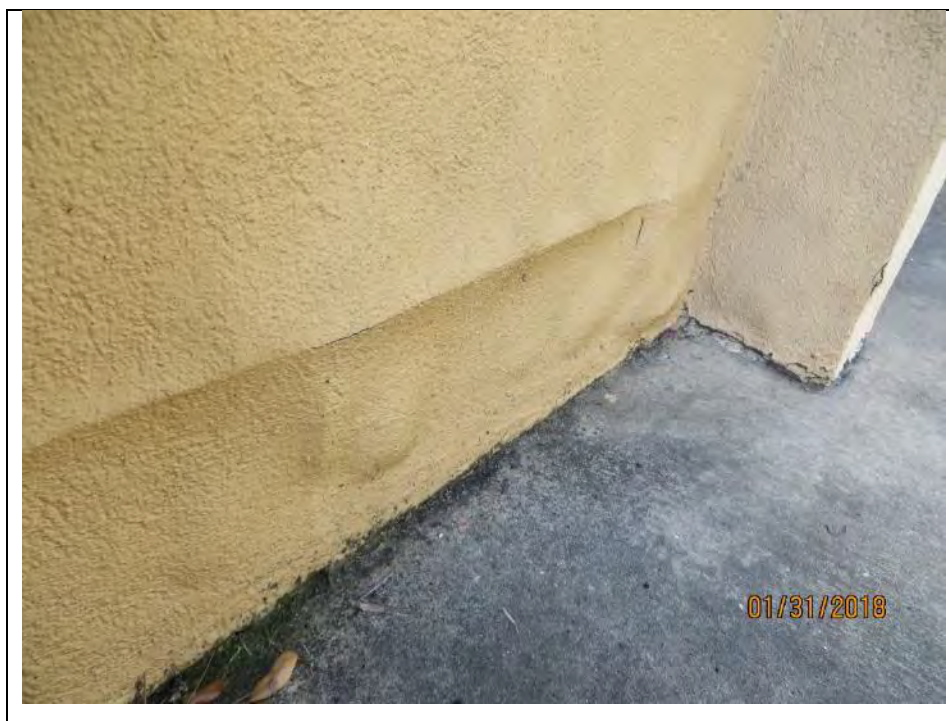
Figure 57. Bulging stucco (KJS)

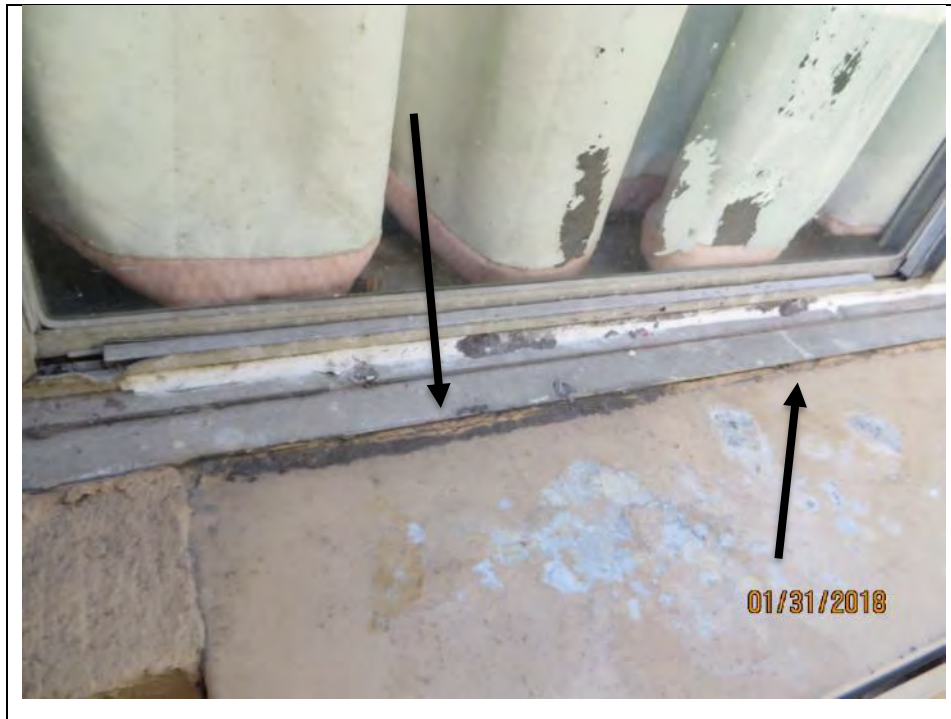
Figure 69. Window pushed in (KJS)

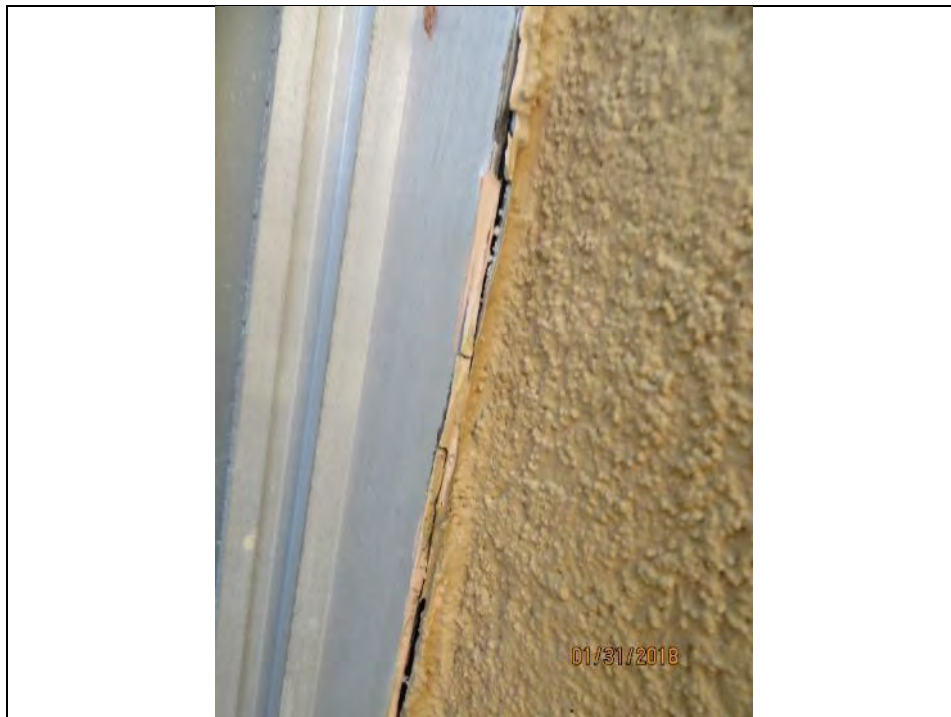
Figure 70. Window movement (KJS)

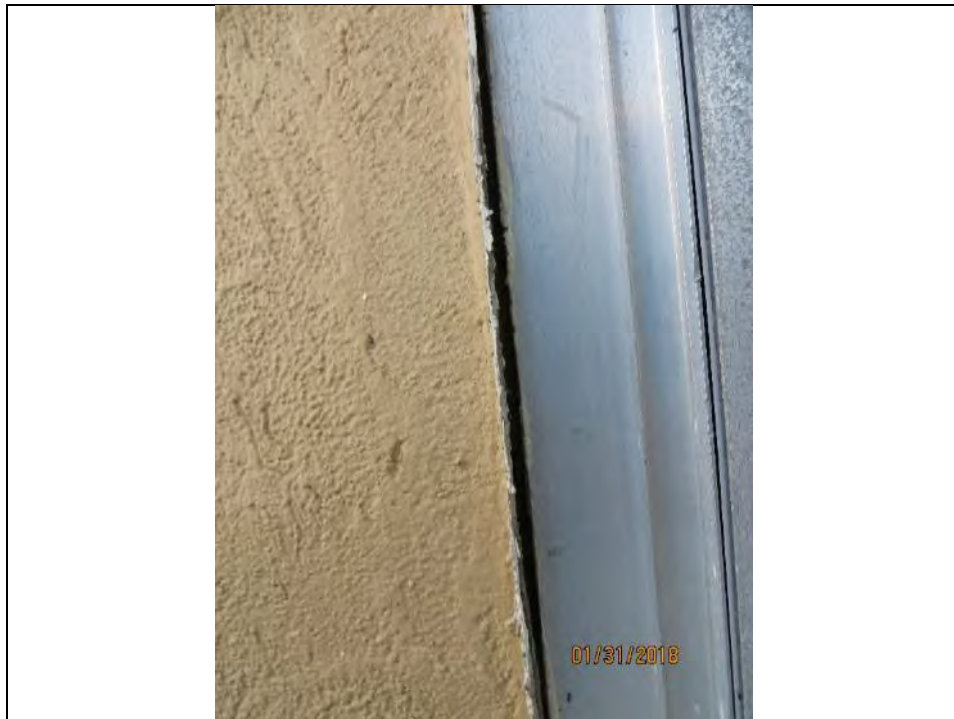
Figure 91. Window separation (KJS)

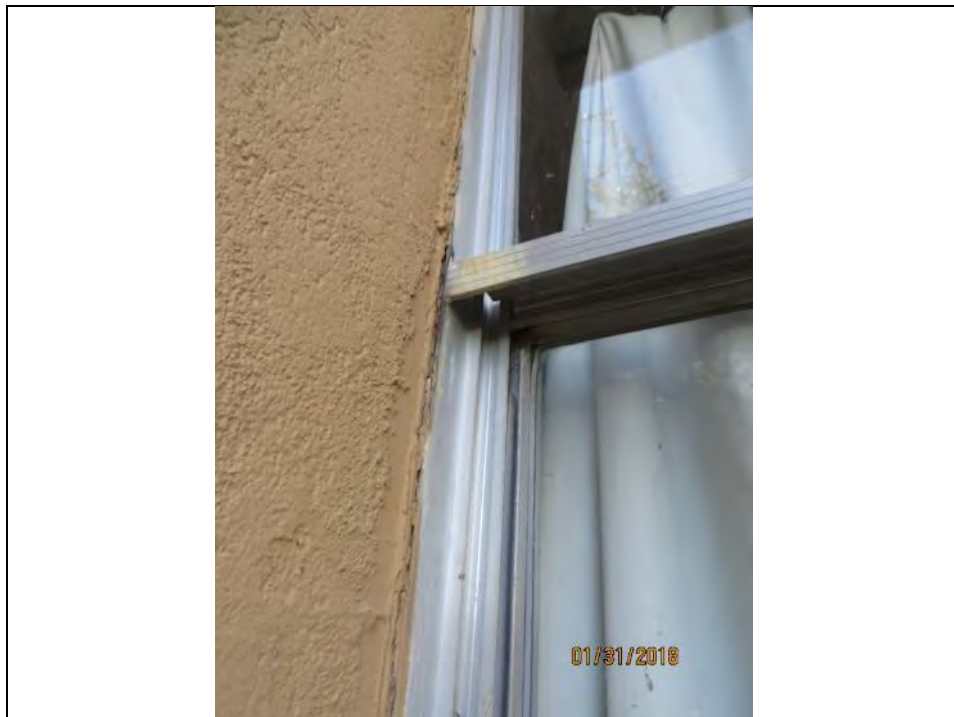
Figure 100. Window separation (KJS)

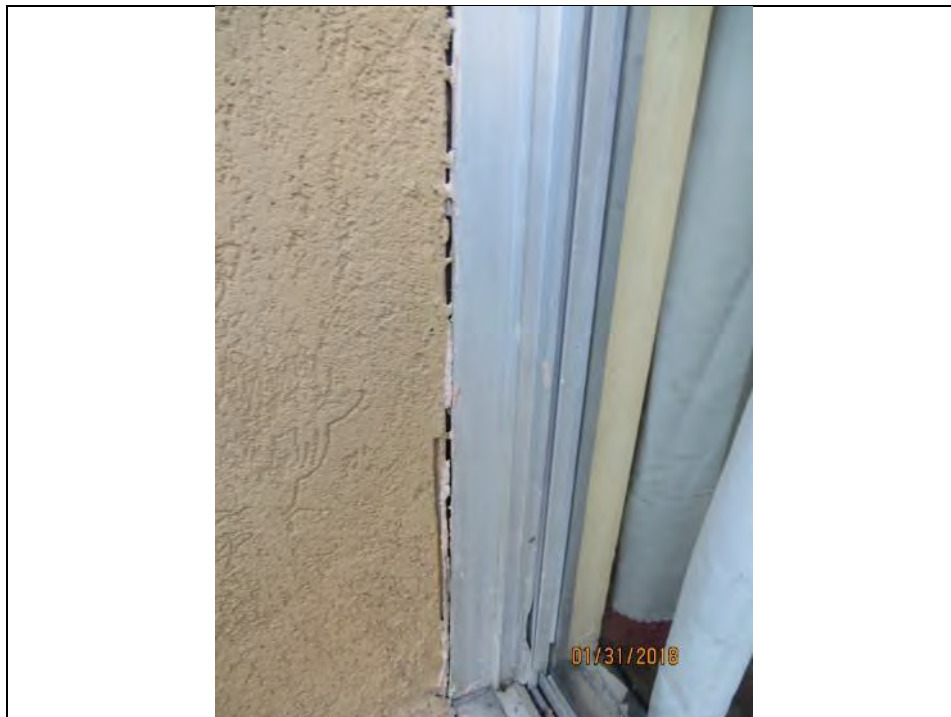
Figure 106. Window separation (KJS)

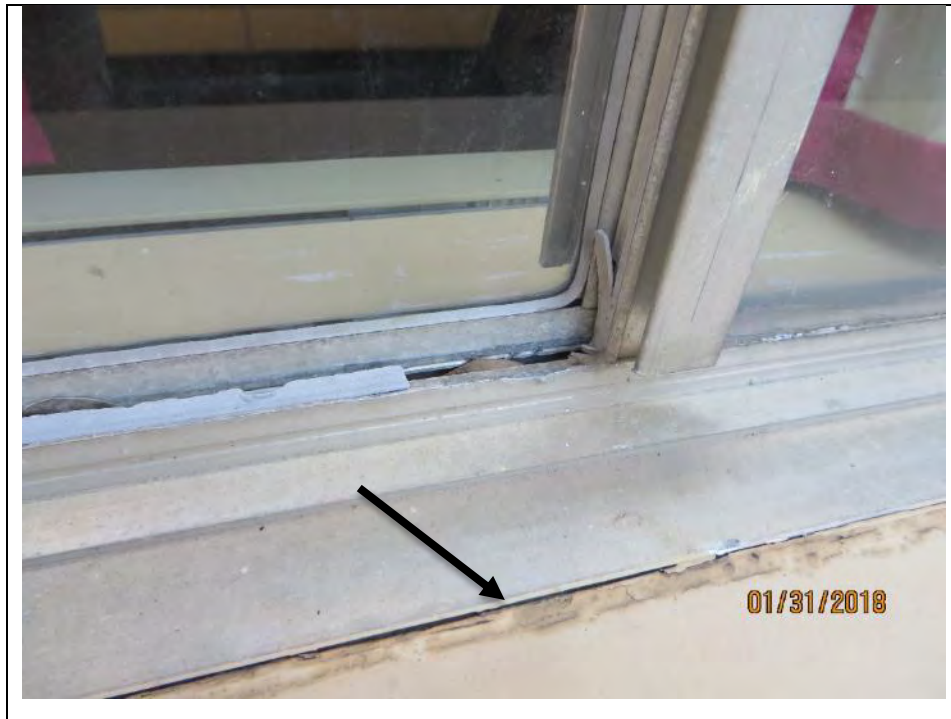
Figure 139. Window movement (KJS)

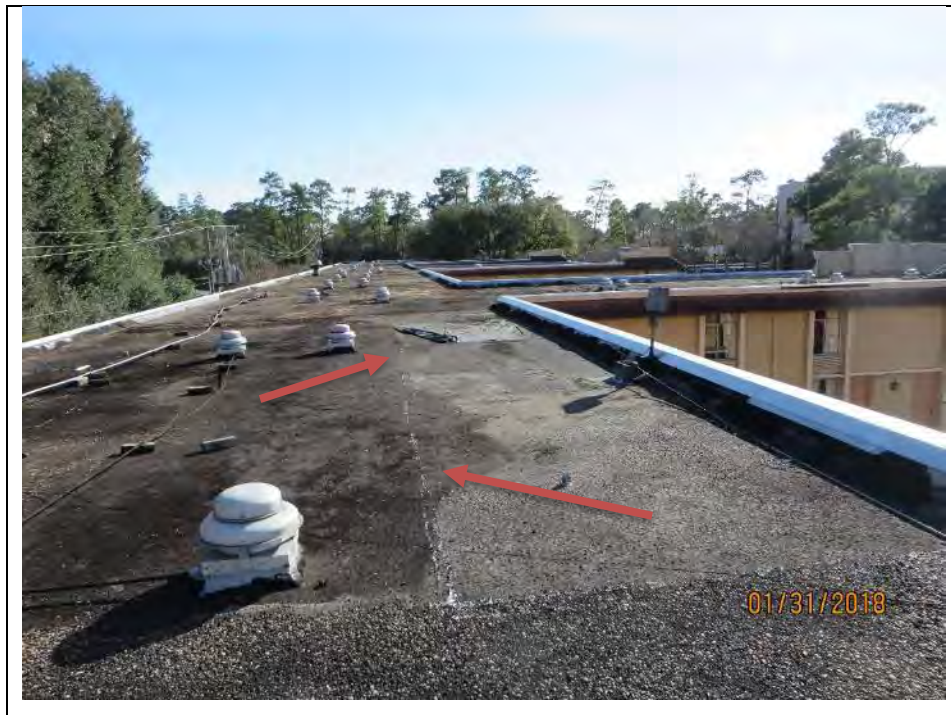
Figure 228. Cap sheet lifted (KJS)

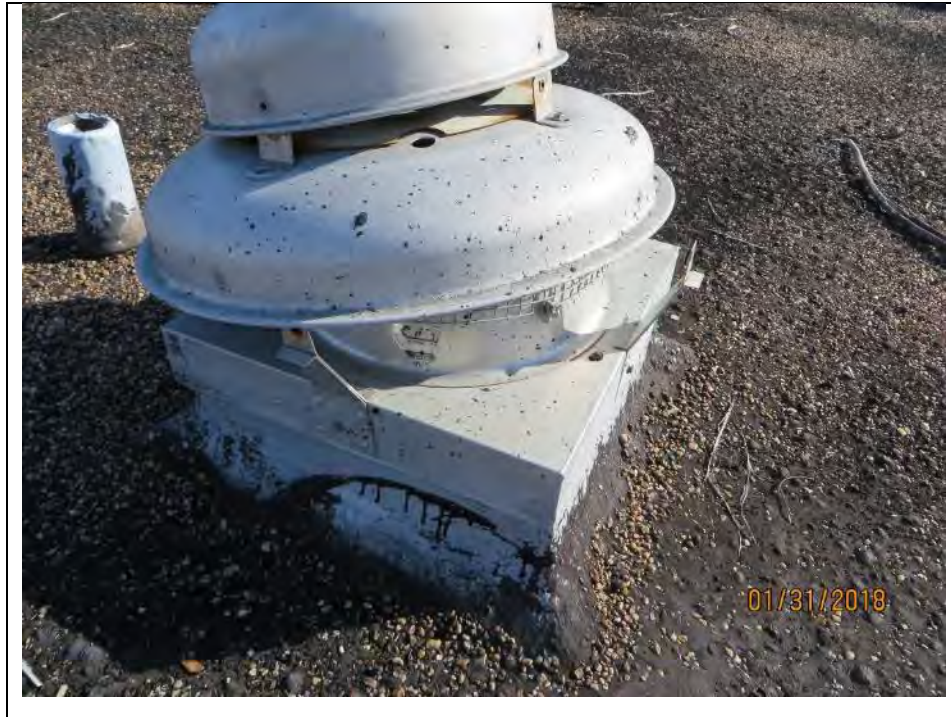
Figure 259. Cap displaced by wind (KJS)

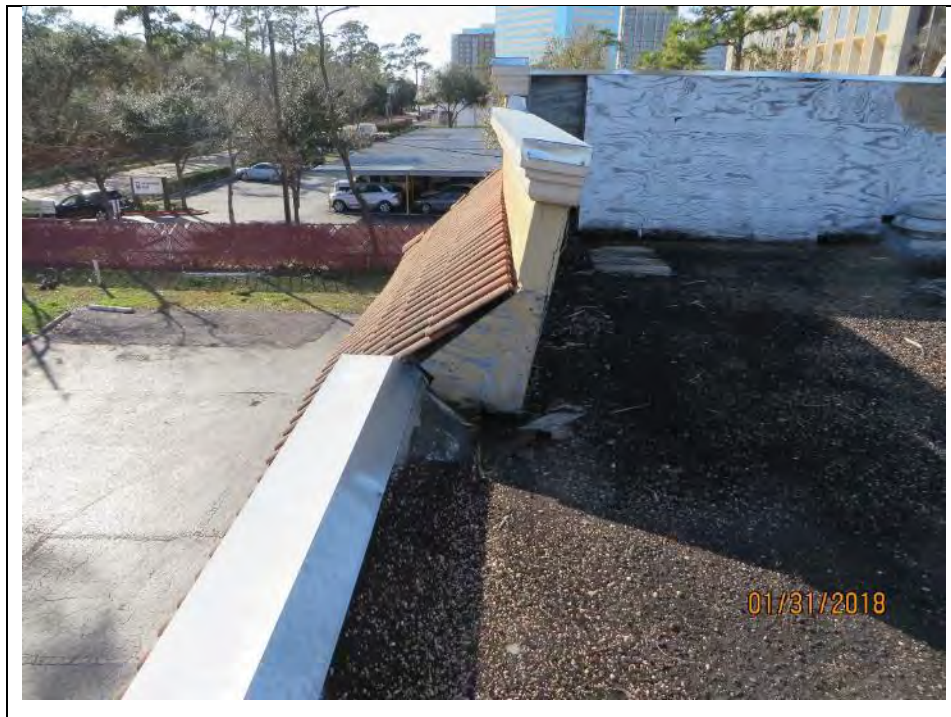
Figure 262. Parapet tipped in after event (KJS)

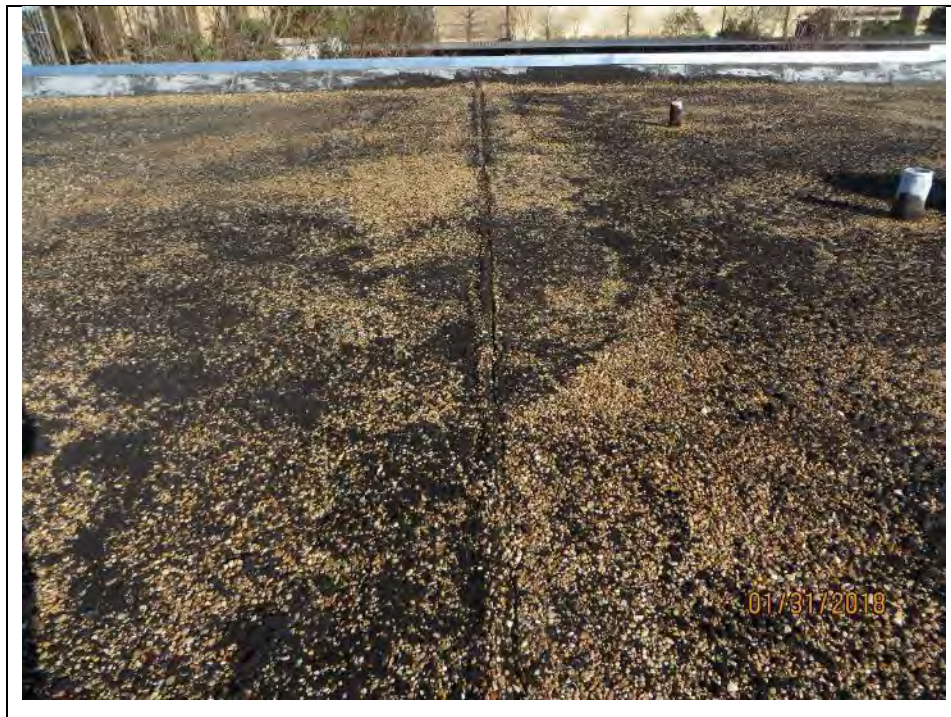
Figure 284. Separation of cap sheet (KJS)

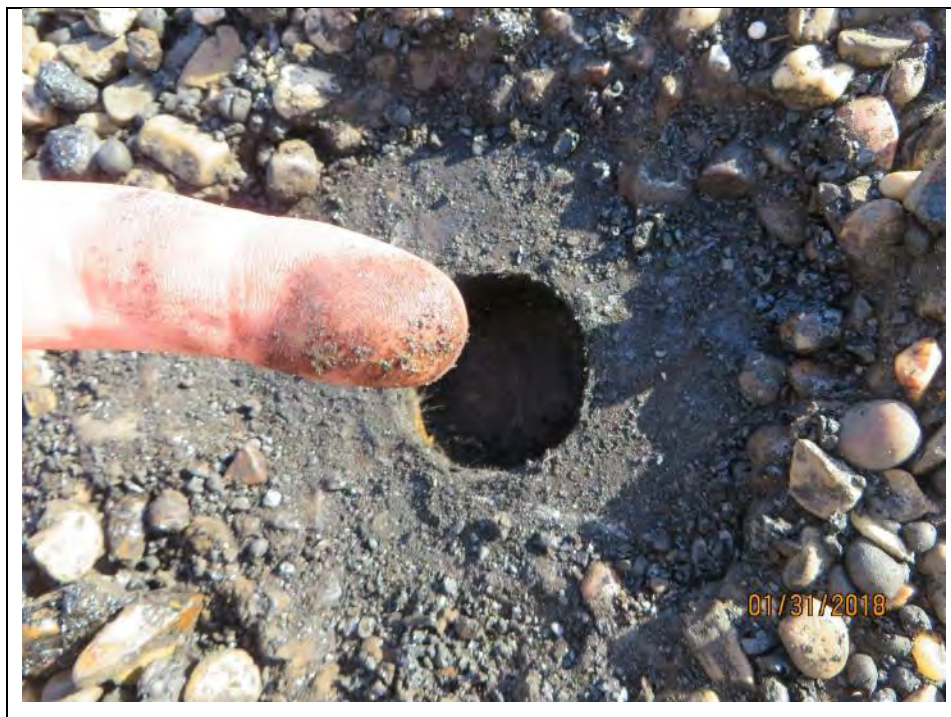
Figure 298. Wet (KJS)

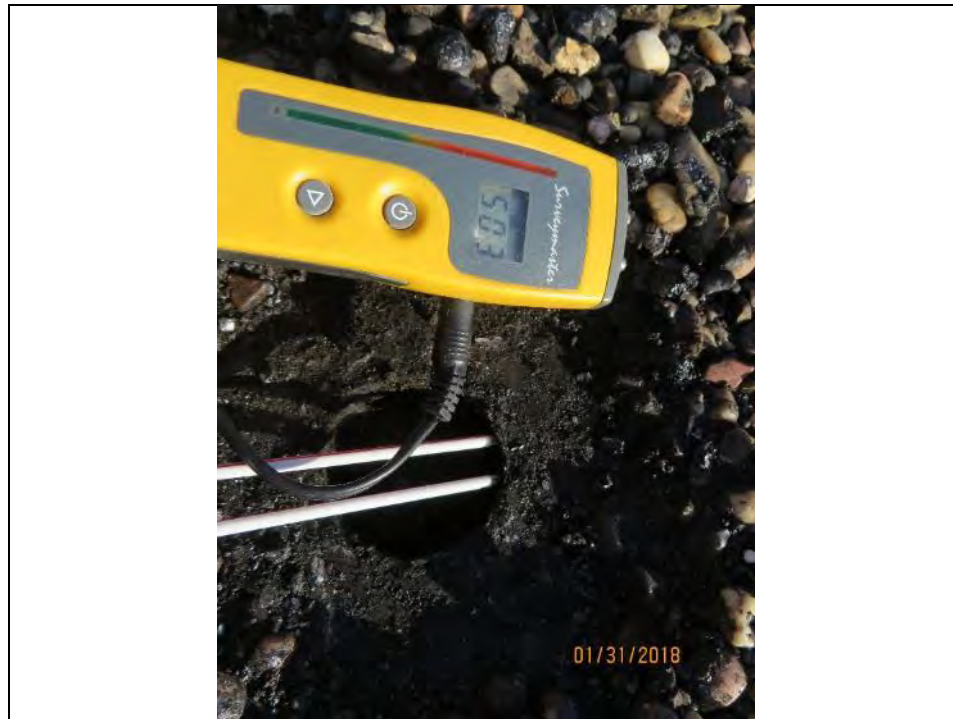
Figure 303. Wet (KJS)

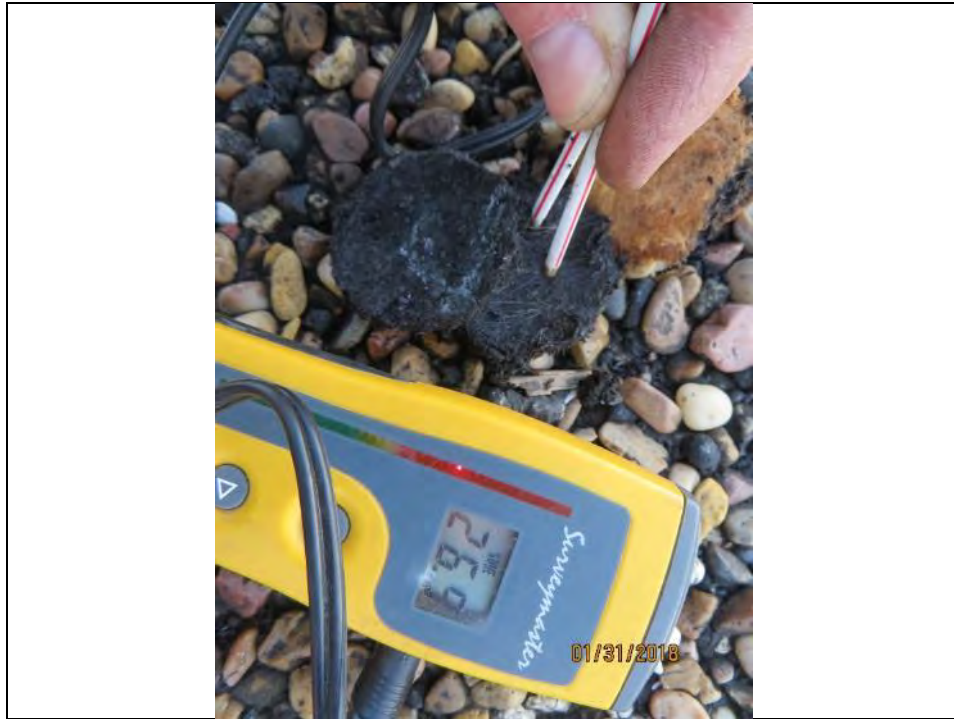
Figure 317. Wet (KJS)

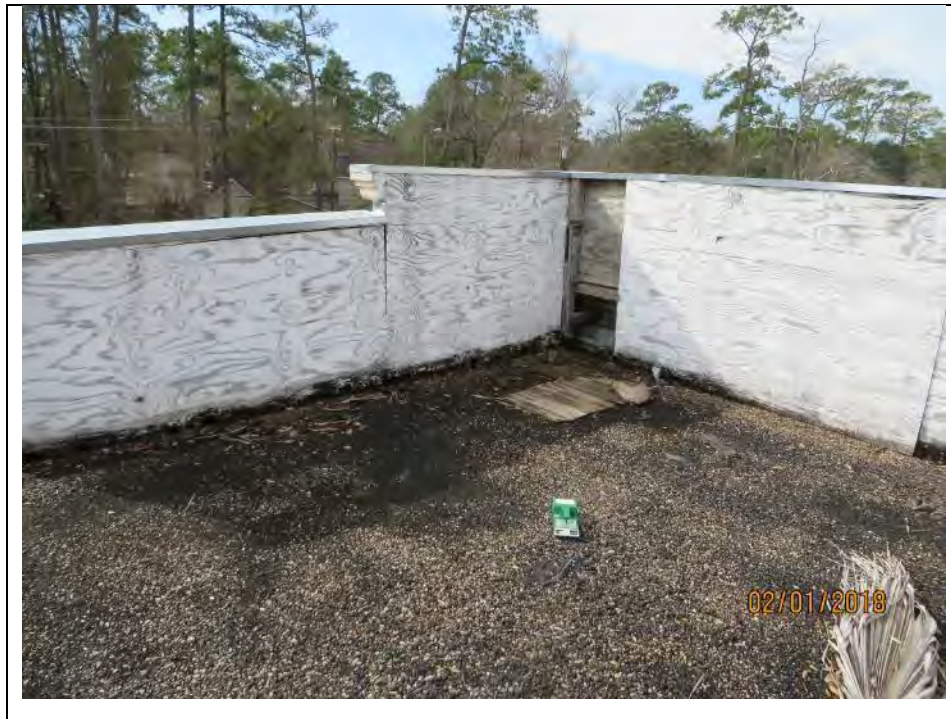
Figure 03. Location of reading in previous photo. (KJS)

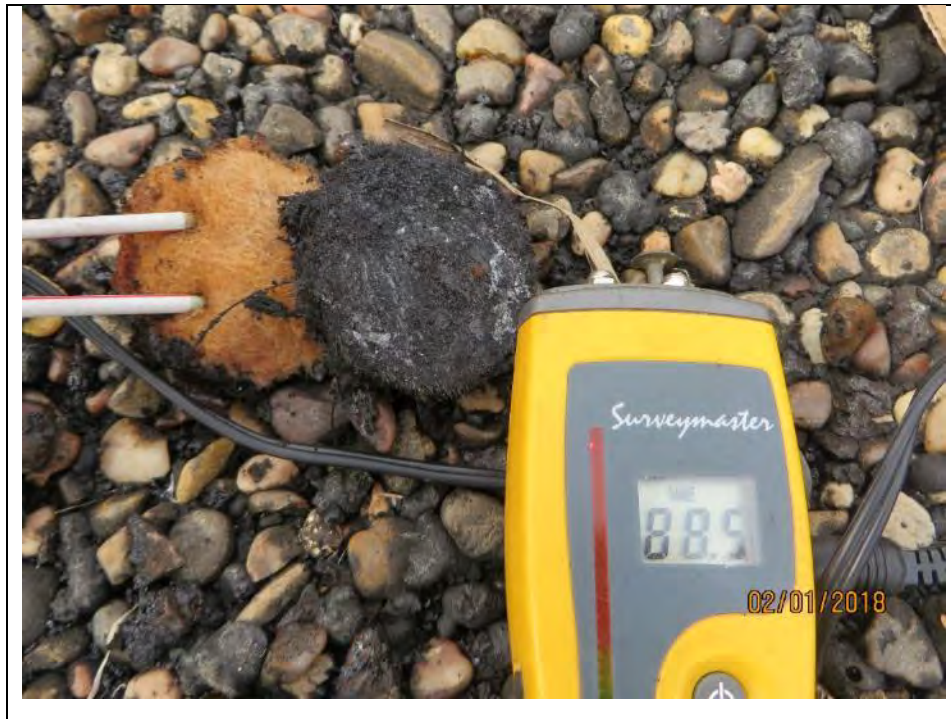
Figure 09. Sample wet (KJS)

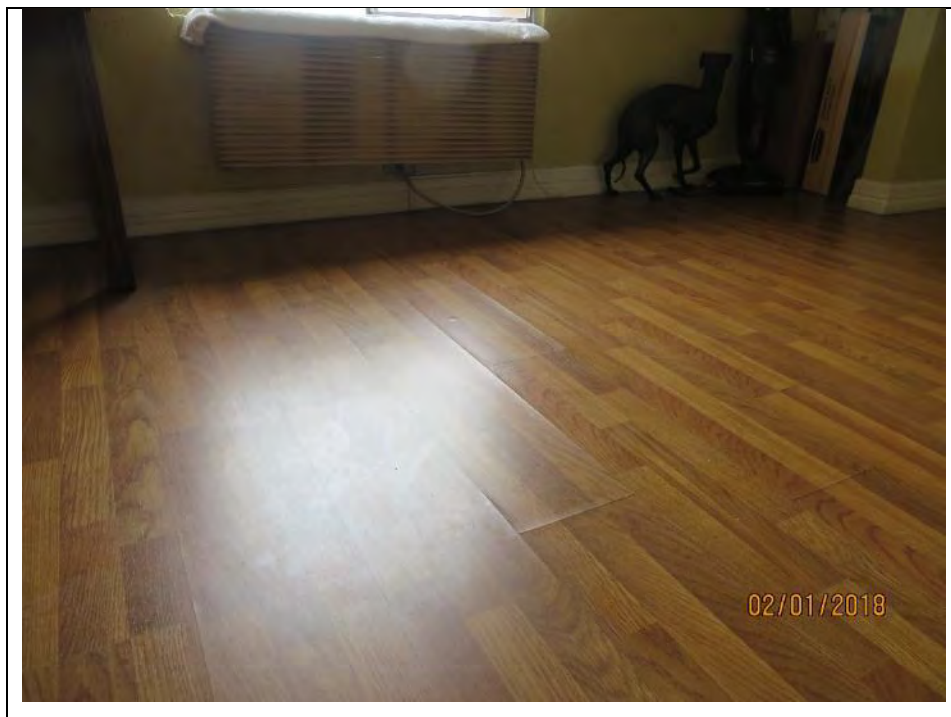
Figure 14. Laminate floor buckled (KJS)

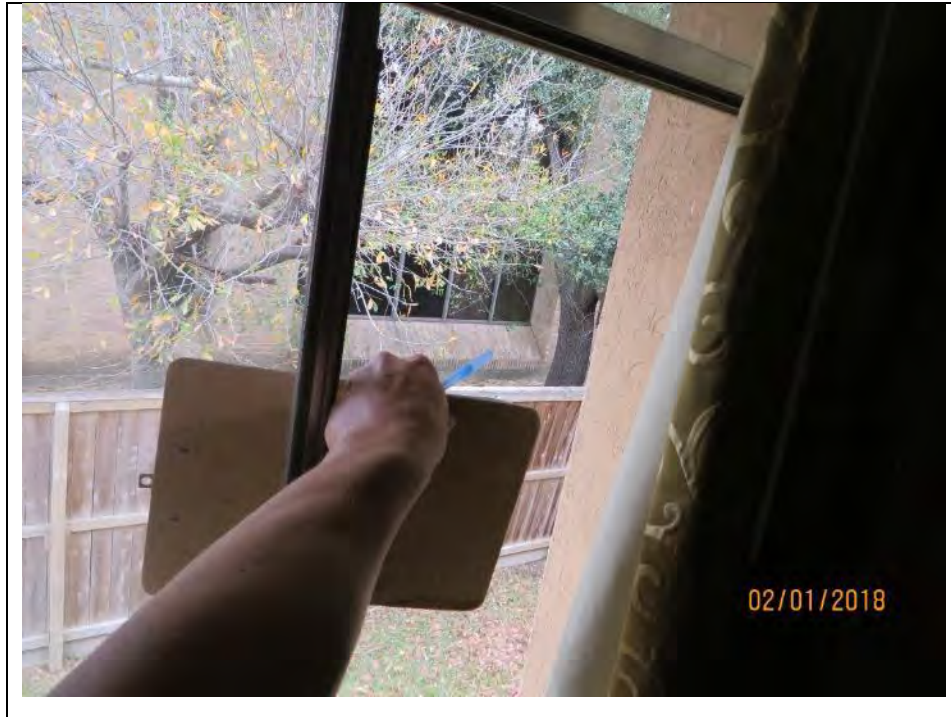
Figure 37. Window bowed (KJS)

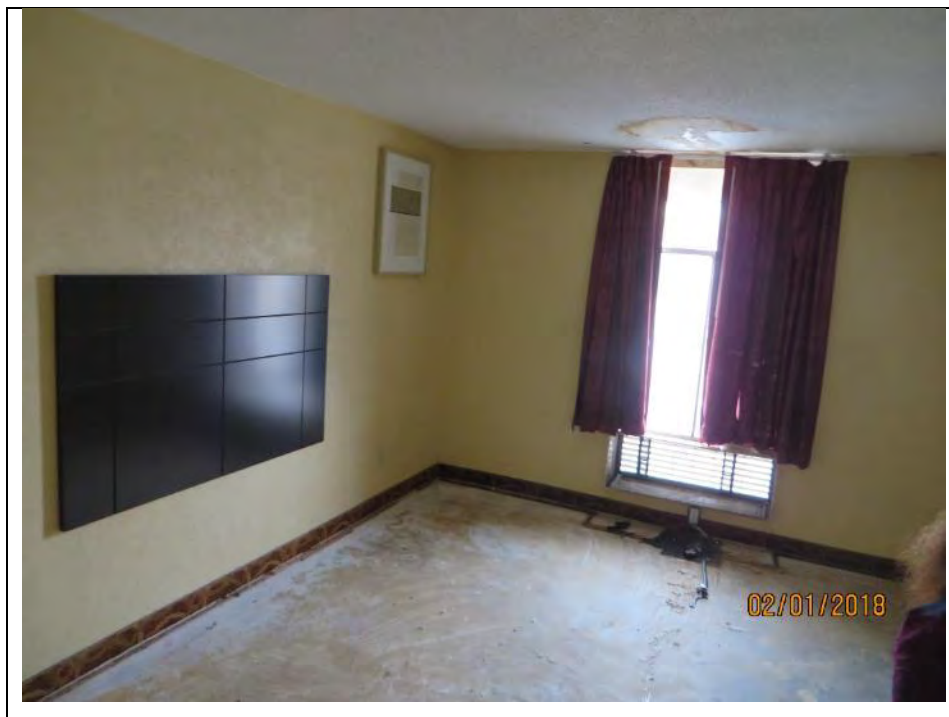
Figure 82. Typical water damage after storm (KJS)
